## Investigation of the effect of wrinkle features on wind turbine blade sub-structure strength

Bender, J. J.; Hallett, S. R.; Lindgaard, E.

*Published in:*  
Composite Structures

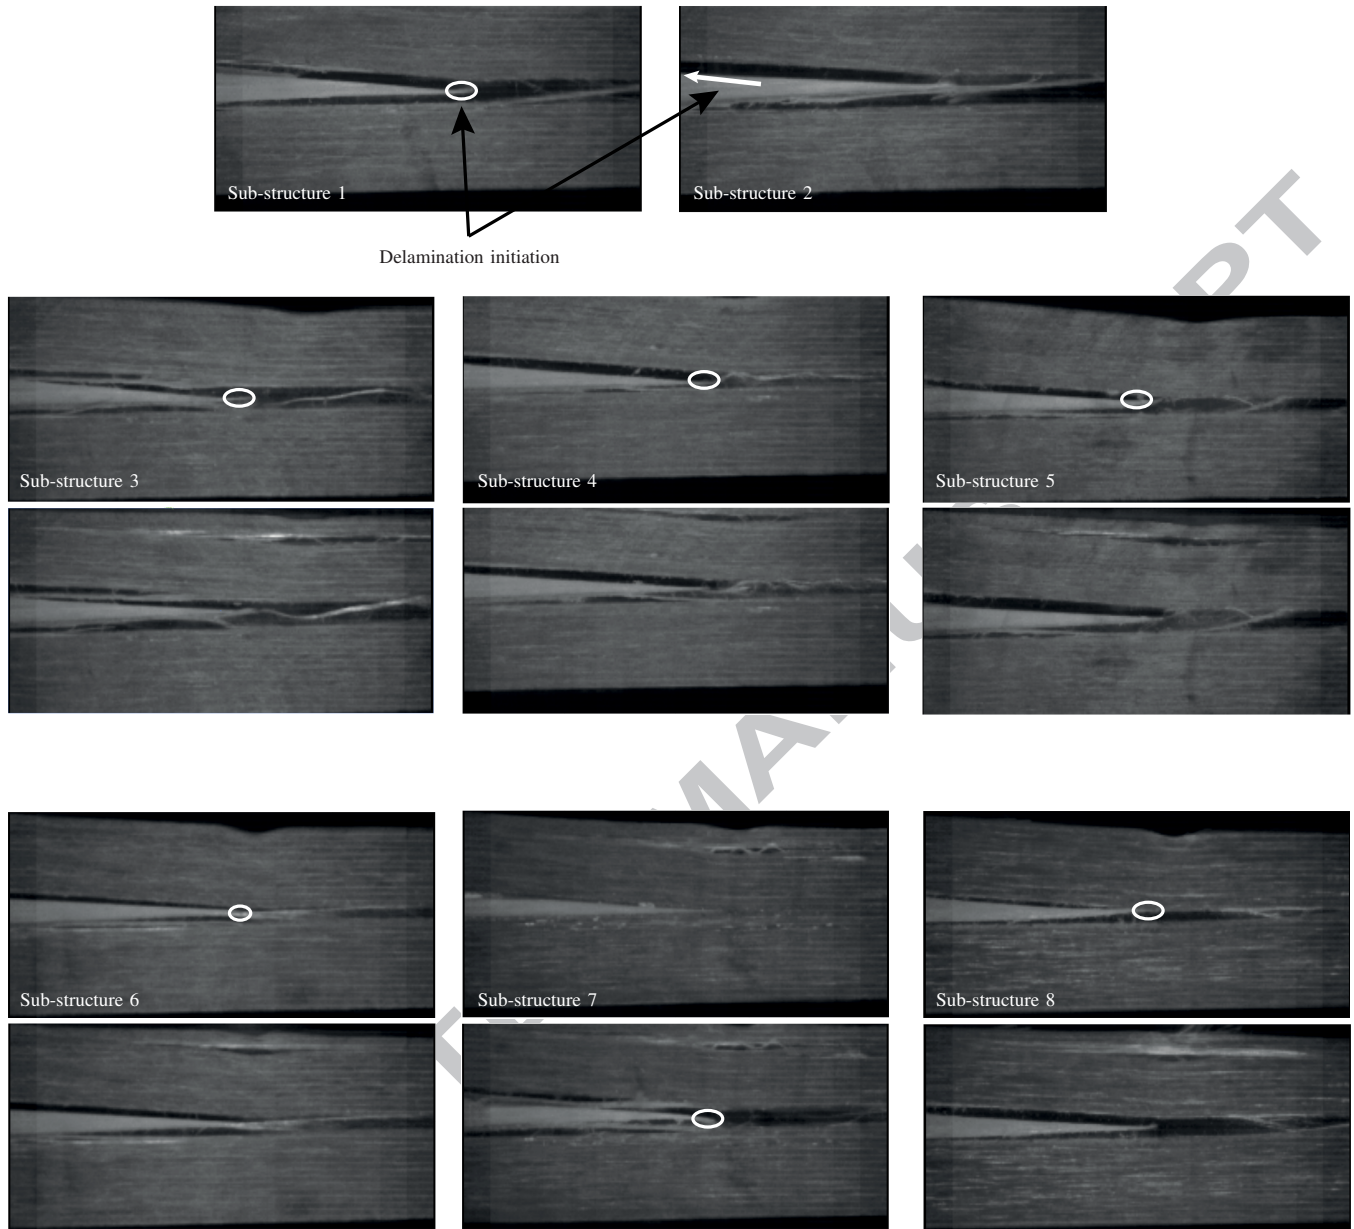
**Fig. 11** High speed camera results. The upper image for all sub-structures shows the damage state after insert delamination except for sub-structure 7, and the lower image shows the damage state after wrinkle delamination except for sub-structure 1, 2, and, 7. The white circles indicate the delamination initiation point, the white arrow in sub-structure 2 indicates that initiation was outside the frame.

Images from the high speed camera are shown in Fig. 11. The

initiation point for the delamination at the tapered insert is indicated with a white circle, except for sub-structure 2 where the initiation happened outside the frame. For all the other sub-structures, the delamination at the tapered insert initiated at the tip of the insert. For the pristine sub-structures 1-2 only one frame is shown at full opening, and two frames are shown for the wrinkled sub-structures. One frame shows the sub-structure right before delamination at the wrinkle, and one frame shows the sub-structure at wrinkle delamination. All the sub-structures delaminated on the top and bottom of the insert, and on the thin side of the laminate as well. Delamination occurred at the insert first and then at the wrinkle for all wrinkled sub-structures except number 7, where the order was reversed. The special behaviour of sub-structure 7 was duplicated numerically through a numerical model where the width was increased, as described in more detail in the next section. The time from initiation of the insert delamination until complete delamination was less than 1ms.
